# Forest Drive Stream Erosion Assessment and Conceptual Alternatives Development

September 2022

Prepared for:  
**City of Bedford, Texas**

**FREESE AND NICHOLS, INC.**

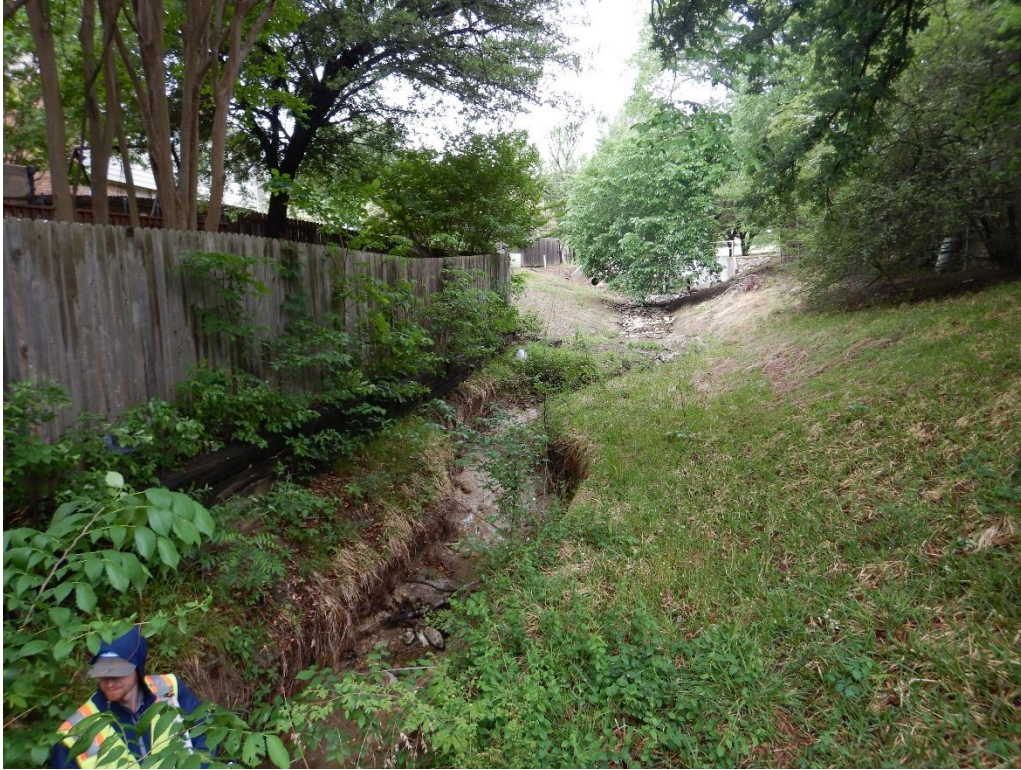
**Station 0+00 - Station 5+00** – The first 500 feet of channel is in the beginning stages of downcutting. The stream is not yet deeply incised (vertical degradation) but numerous headcuts and grade breaks were observed. The channel bottom has cut down into the underlying bedrock, which is composed of slakable/erodible Marl. Channel widening and lateral erosion were observed insolated locations through this reach. If left unaddressed, an estimated 4-feet of downcutting could occur. Infrastructure in this reach includes:

Station 1+00 - Looking upstream the beginning stages of downcutting and headcut migration can be observed. This photo shows **Area of Concern #1**.

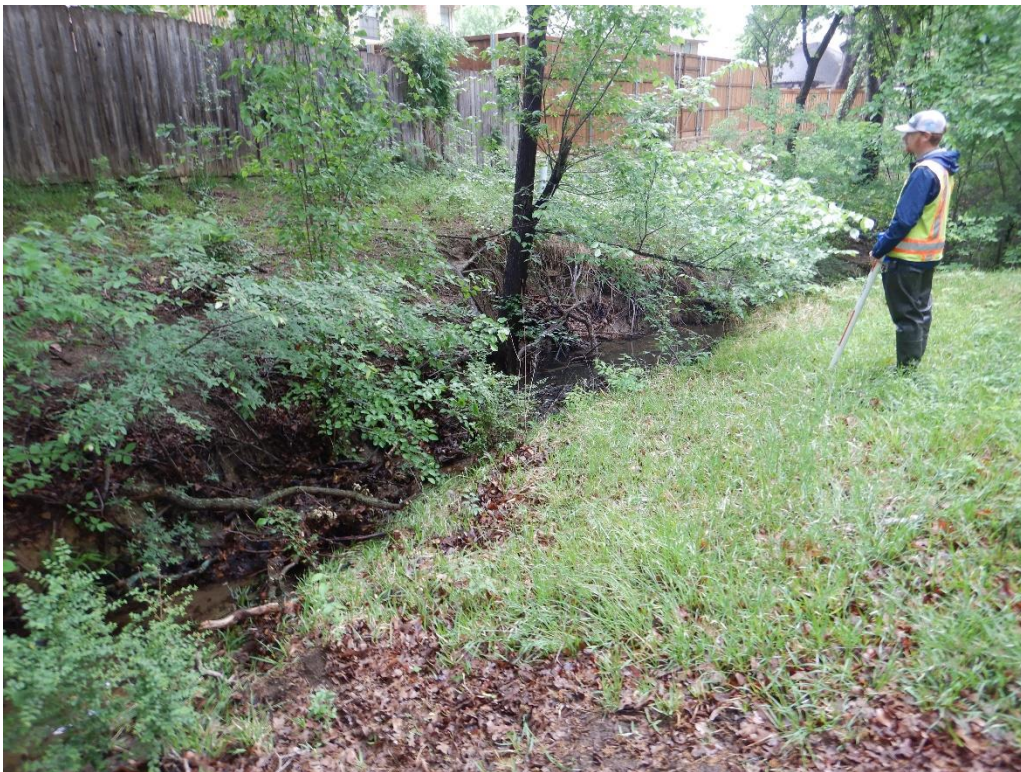
Station 3+25 - Looking at left bank, this photo shows representative conditions, including isolated bank erosion near home backyards. This photo illustrates the concern with **Area of Concern #2**.

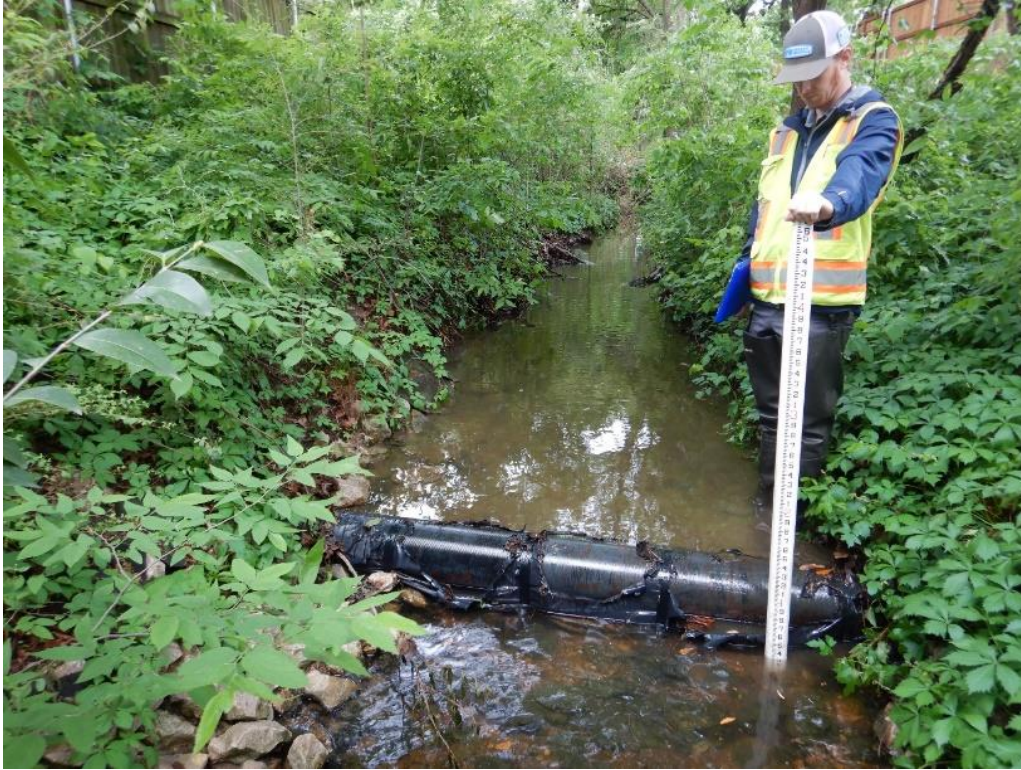
Station 4+50 - Looking upstream, this photo shows the exposed sewer line at this location and illustrates the concern with **Area of Concern #3**.

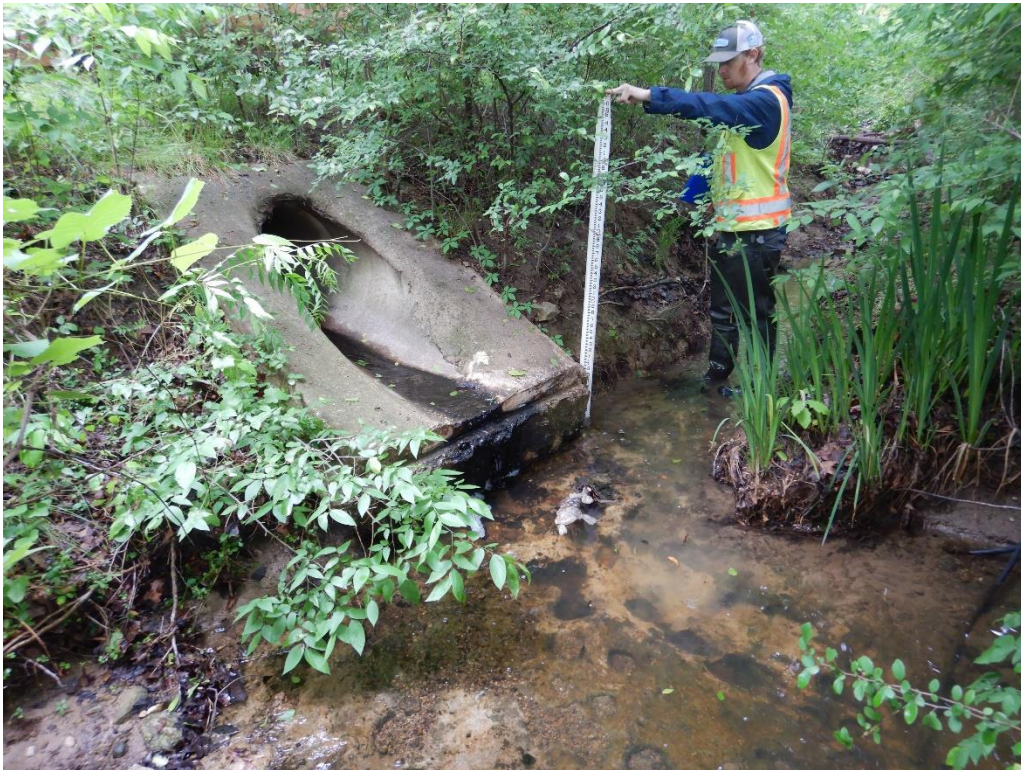
- A stormwater outfall at Station 5+75. The foundation of the outfall is on the bedrock channel bottom. At present, the outfall appears to be in functioning condition. But future downcutting may undercut below outfall.
- A stormwater outfall at Station 7+75. Downcutting has occurred leading to undermining of this structure by scour.
- An exposed sewer line at Station 8+50. Rip rap protection has been eroded. Downcutting and bank scour appears to be ongoing. Without grade control measures, downcutting could further threaten the sewer line and allow instabilities to migrate upstream.

Station 5+75 - Looking upstream at the right stream bank, this photo shows the condition of the stormwater outfall and the beginning stages of downcutting at scour (**Area of Concern #4**).

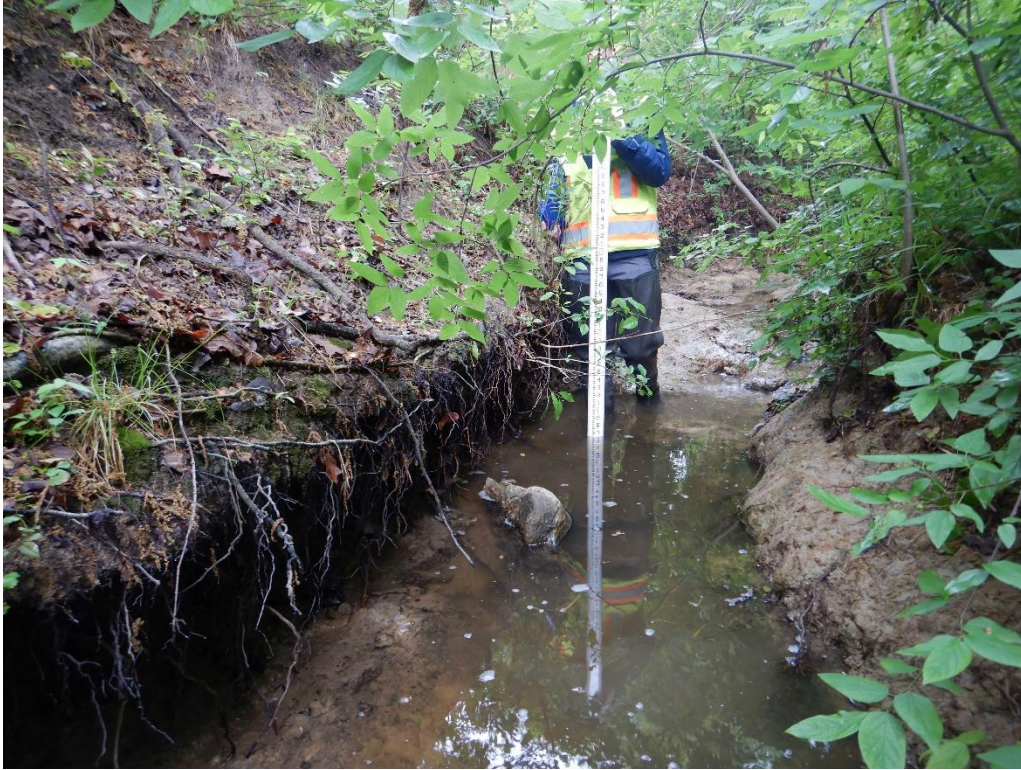
Station 6+00 - Looking upstream, this photo shows a representative example of a headcut propagating upstream.

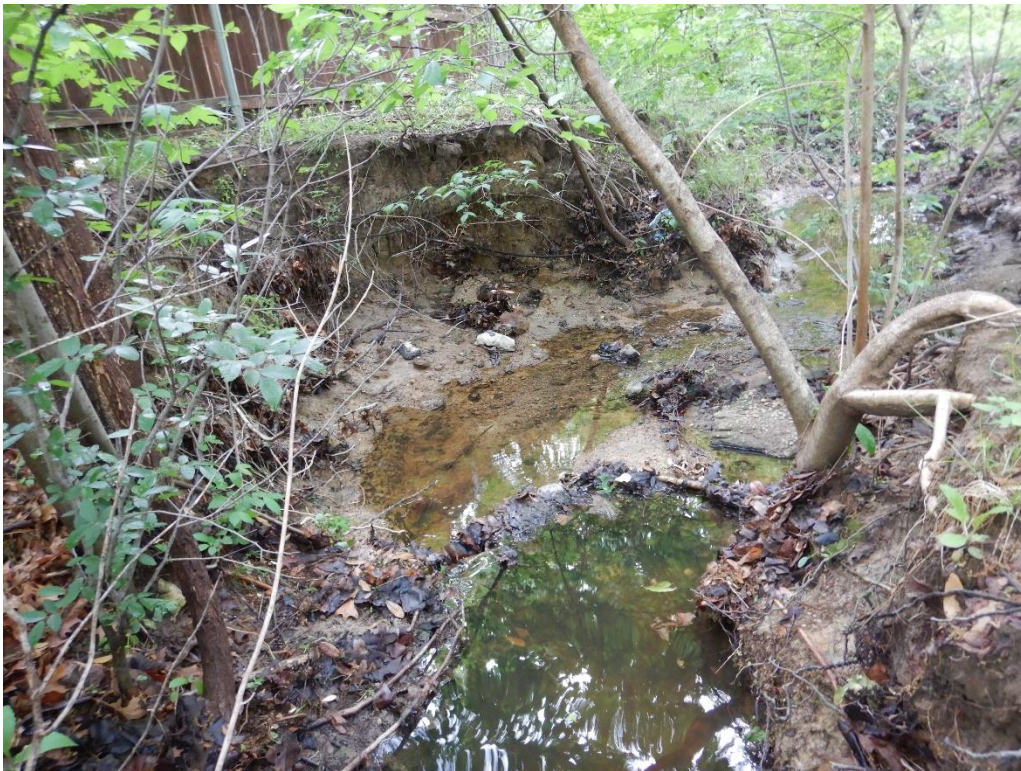
Station 7+00 - Looking downstream, this photo shows representative conditions and bank erosion into home backyards  
**(Area of Concern #5)**

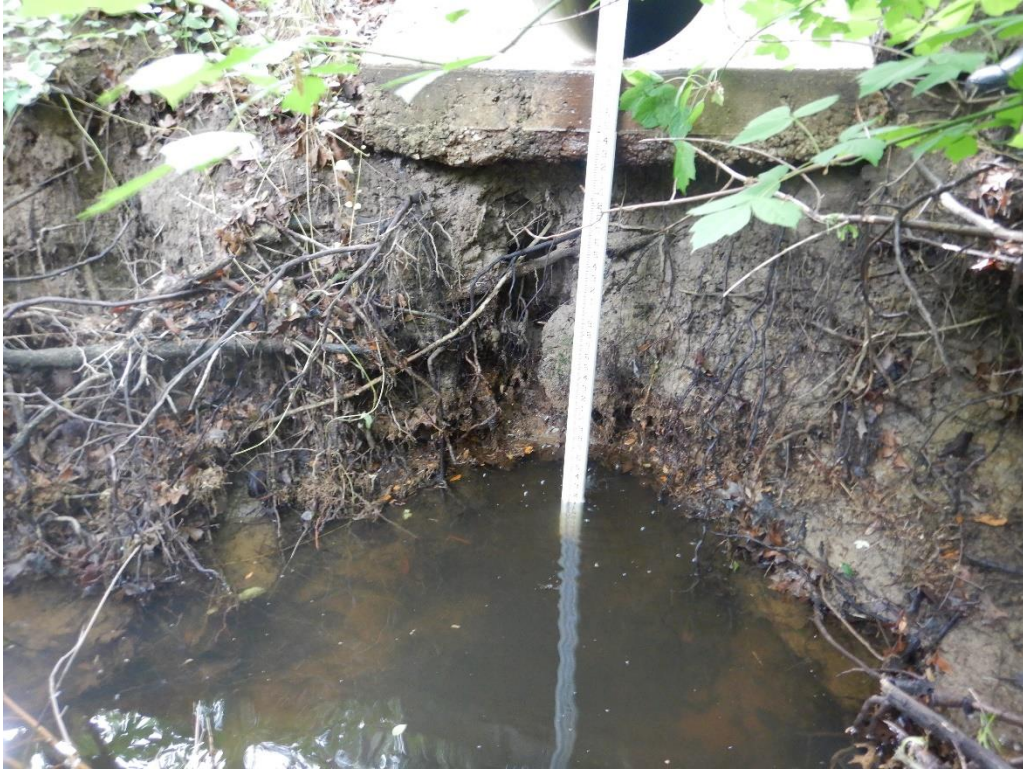
| Location | Impacted Features | Description | Priority |
|---|---|---|---|
| #6<br>Station 7+75 | Stormwater Outfall | A stormwater outfall has been undermined by downcutting on the stream bed. Local scour was observed below the foundation of this structure. | Moderate |

Station 7+75 - Looking at the stormwater outfall on the right stream bank, this photo shows scour beneath this structure (**Area of Concern #6**). Bank scour of similar magnitude is occurring on opposite bank.

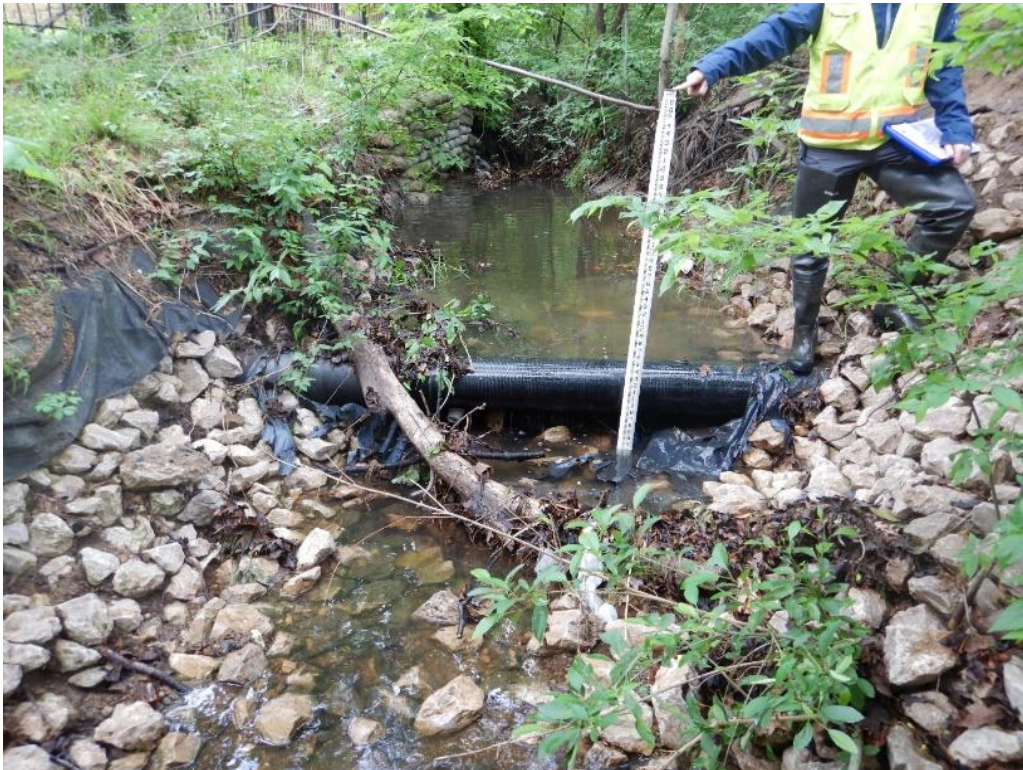
Station 8+50 - Looking upstream at the location of an exposed sewer line (**Area of Concern #7**). This photo shows how the sewer line is holding the grade of the stream.

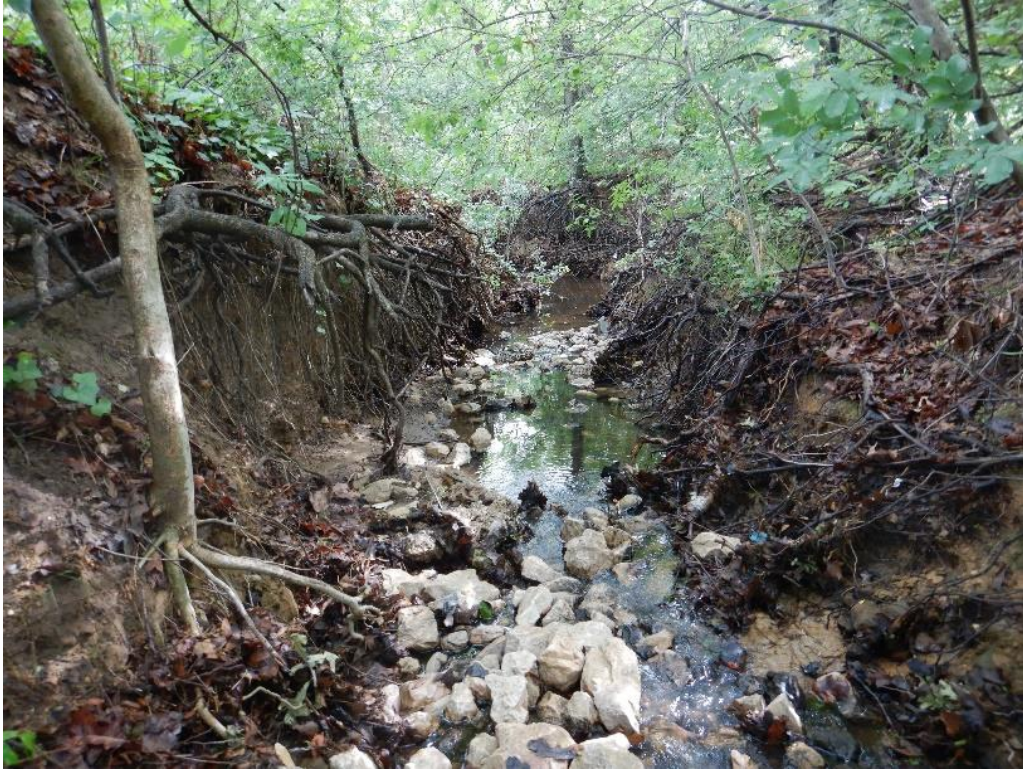
Station 8+50 - Looking downstream from the exposed sewer line showing the scour and bank erosion adjacent to **Area of Concern #7**.

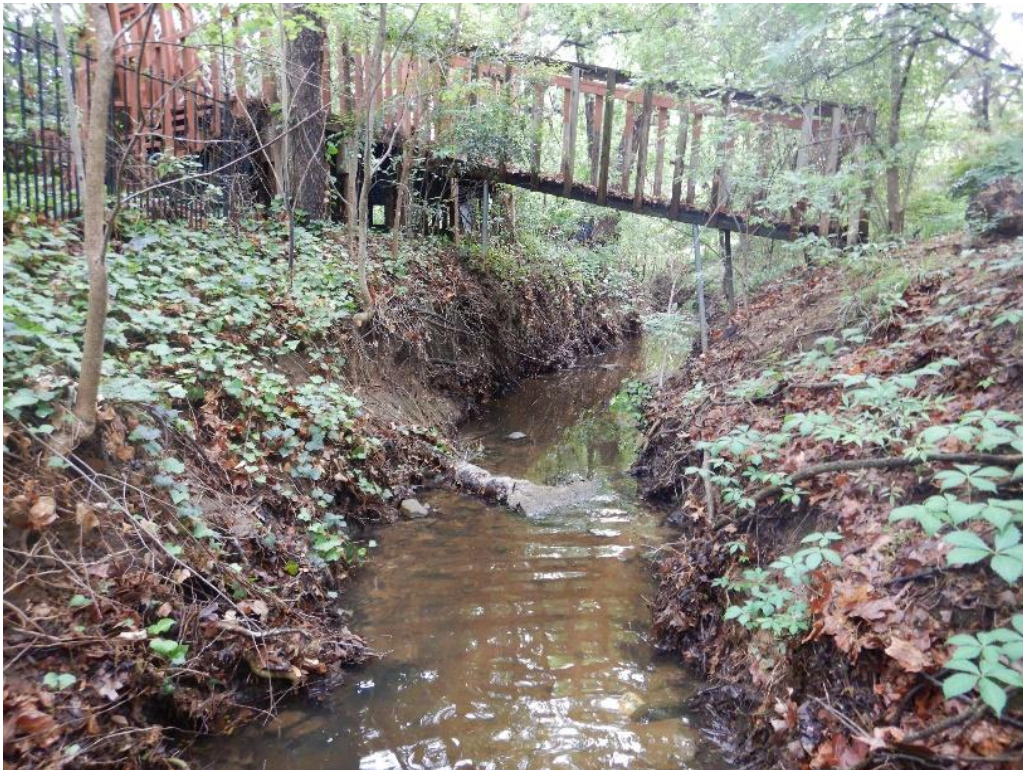
Station 9+00 - Looking downstream, this photo shows the representative conditions of the channel between station 6+00 and 10+00, also showing the concerns with **Area of Concern #5**

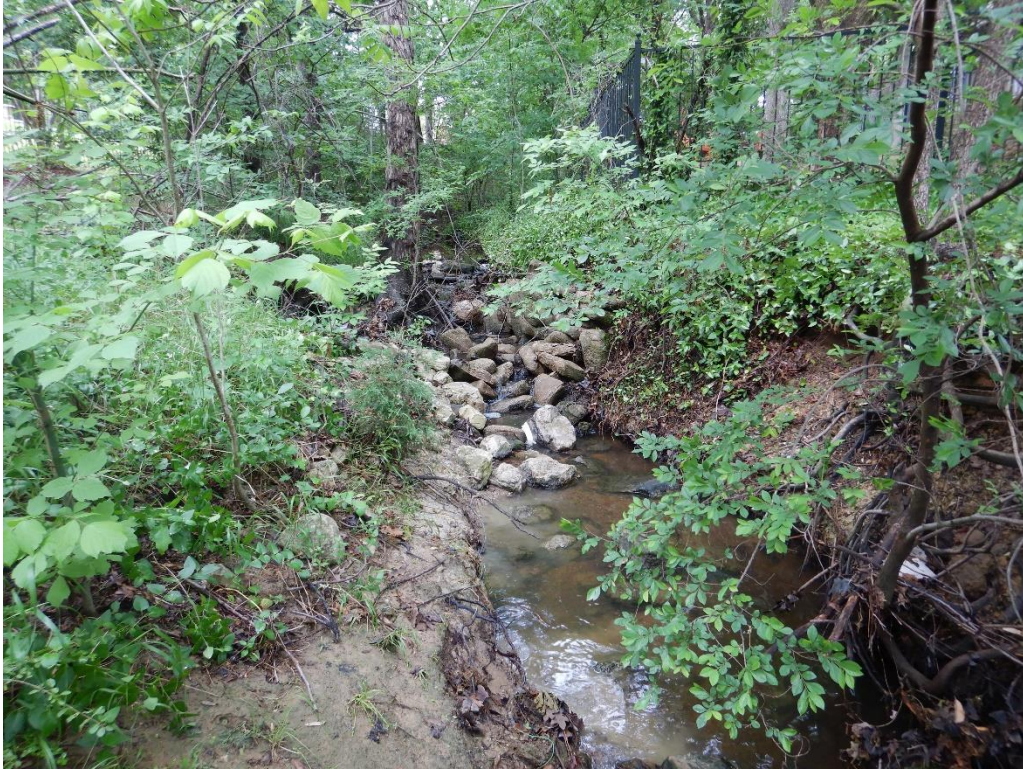
| Location | Impacted Features | Description | Priority |
|---|---|---|---|
| #8<br>Station 10+75 – 11+25 | Homes, Upstream Impacts | There is an approximately 3-foot headcut that is migrating upstream at this location. It appears that rip rap has been placed over this change in slope. However, this stone is being eroded. Immediately downstream subsequent bank erosion has occurred and is less than 20-feet from the foundation of a home along the stream. | High |

Station 10+75 - Looking upstream, this photo shows a headcut that is propagating upstream, and landowner attempts to prevent erosion impacts into back yards (**Area of Concern #8**).

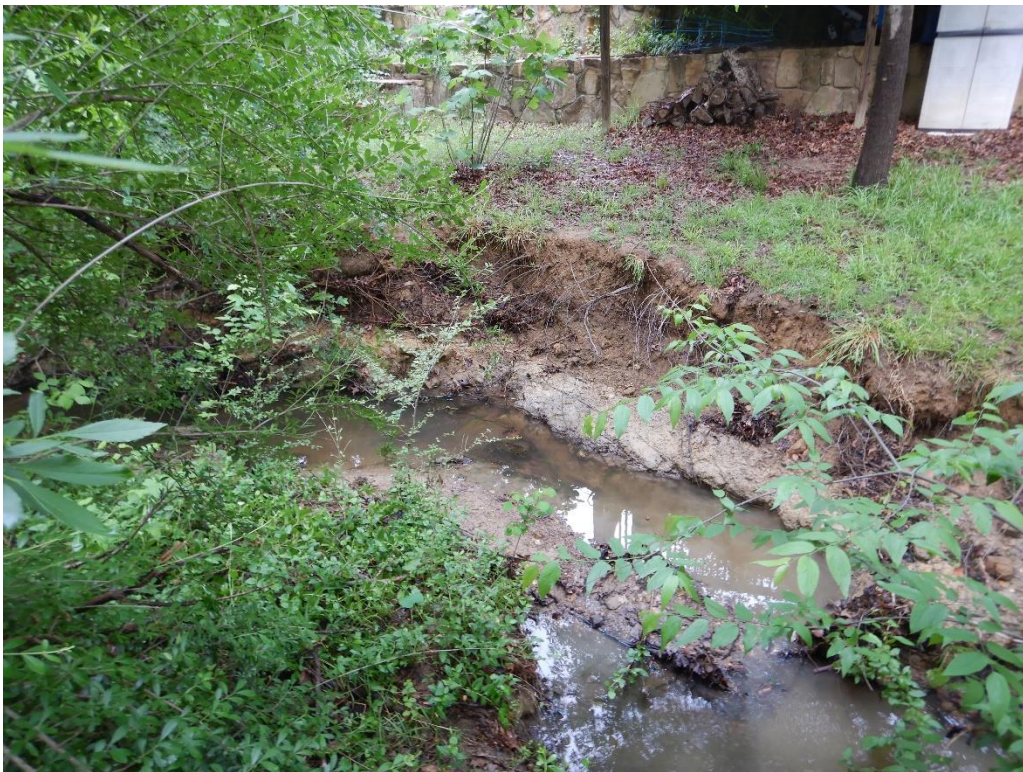
Station 11+25 - Looking at the left stream bank, this photo shows the bank erosion below the headcut and impacts to a nearby property (**Area of Concern #8**).

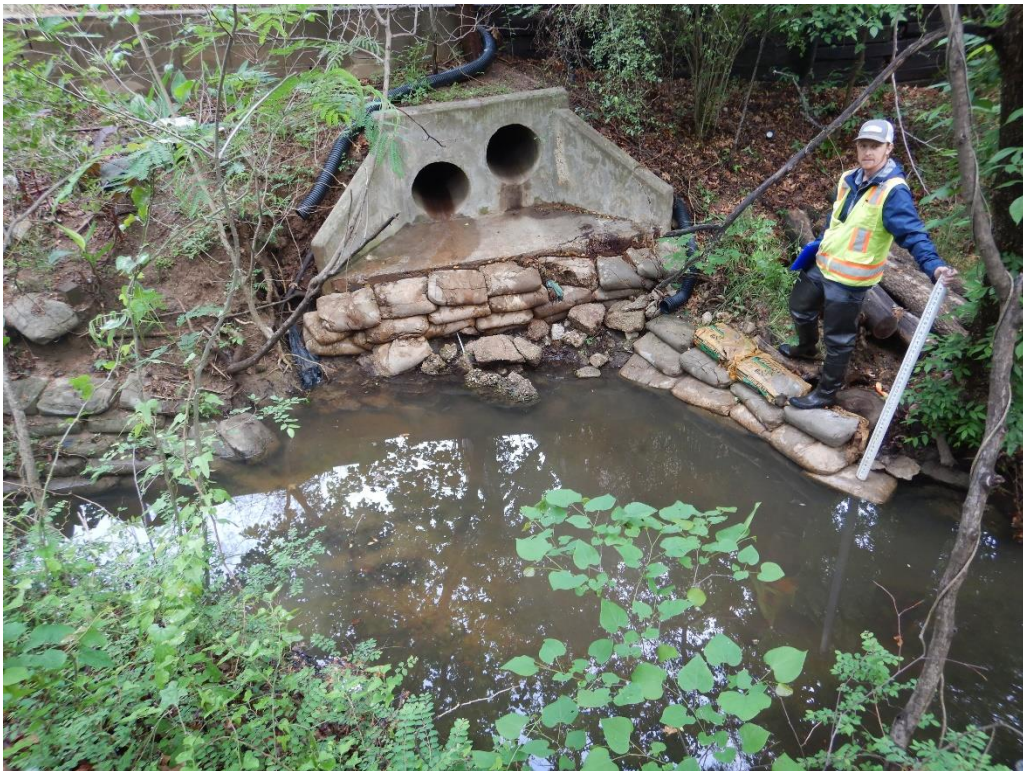
- A stormwater outfall at Station 13+00. This structure is in poor condition. Bag walls have been built around the outfall, but local scour appears to be occurring.

| Location | Impacted Features | Description | Priority |
|---|---|---|---|
| #9<br>Station 13+00 | Stormwater Outfall | The stormwater outfall present at this location is being impacted by local scour. A bag wall is present to protect this structure but is in poor condition. | Moderate |

Station 13+00 - Looking at the left stream bank, this photo shows the condition of a stormwater outfall  
**(Area of Concern #9).**

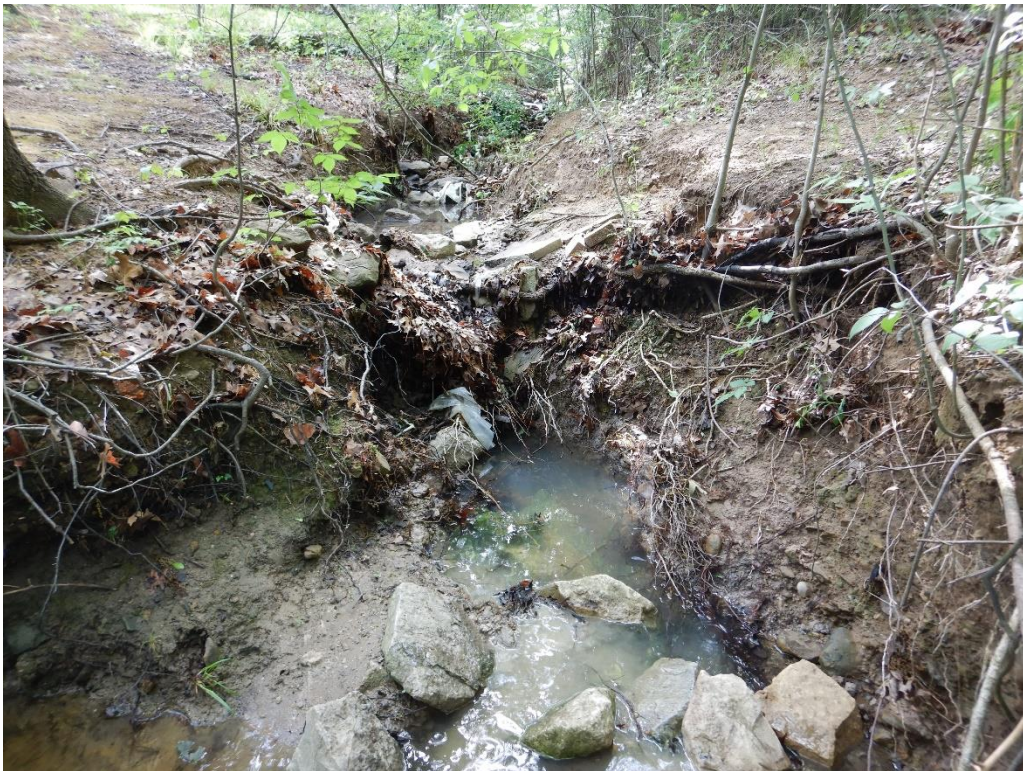
Station 14+50 - Looking upstream, this photo shows an approximately 3-foot head cut that may be migrating upstream into a stable section of channel (**Area of Concern #10**).

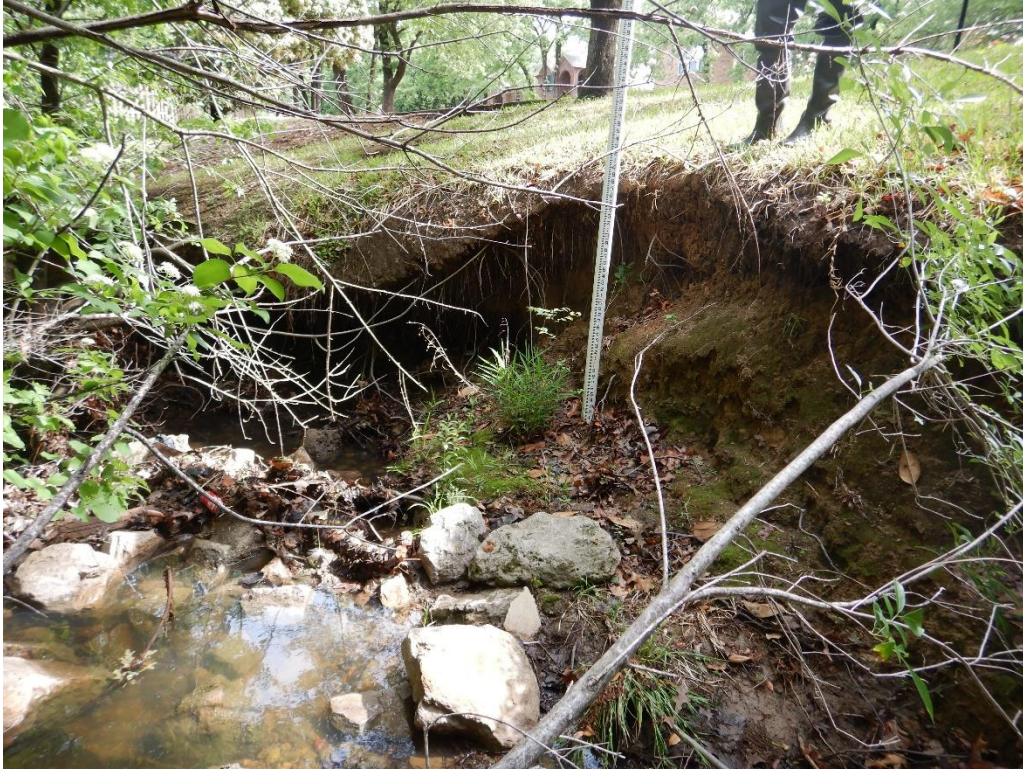
- At Station 14+50 to 15+50, grouted rip rap bank protection is present at the terminus of Creekside Ct. This bank stabilization measure is in poor condition due to scour undercutting the toe. Continued erosion may impact Creekside Ct.

| Location | Impacted Features | Description | Priority |
|---|---|---|---|
| #10<br>Station 14+50 – 15+00 | Creekside Ct, Upstream Impacts | Bank stabilization measures, in the form of grouted rock rip rap, to protect Creekside Court has been undercut by toe scour and is failing. This is due to channel downcutting below the depth of the protection measures. The headcut that initiated this issue is still present and at the upstream extent of the bank protection. Any measures to address this issue should also incorporate grade control to protect upstream reaches from migrating instabilities. | High |

Station 14+90 - Looking at right bank, this photo shows the bank undercutting immediately upstream of the grouted rip rap protection of Creekside Ct (**Area of Concern #10**).

The purpose of Alternative #1 is to protect an existing eroded slope along the right bank between stations 14+50 and 15+50. The failing bank is within 15 feet from the existing sidewalk along the western edge of the cul-de-sac of Creekside Court. The design will consist of removing the existing rock riprap bank protection which is currently being undermined. The bank will be reconstructed with a hard armored toe protection and mechanically stabilized earth (MSE) on top. Soil anchors are assumed because of the likeliness of traffic loading at the top of the bank. The toe protection will be a minimum of 6 feet in height with the bottom fully buried. Proposed riprap to be placed along the toe of wall and along the channel bottom to mitigate against a knickpoint migrating upstream. An exhibit was created to visually display design elements for Alternative #1 and is attached to this report in **Exhibit D**.

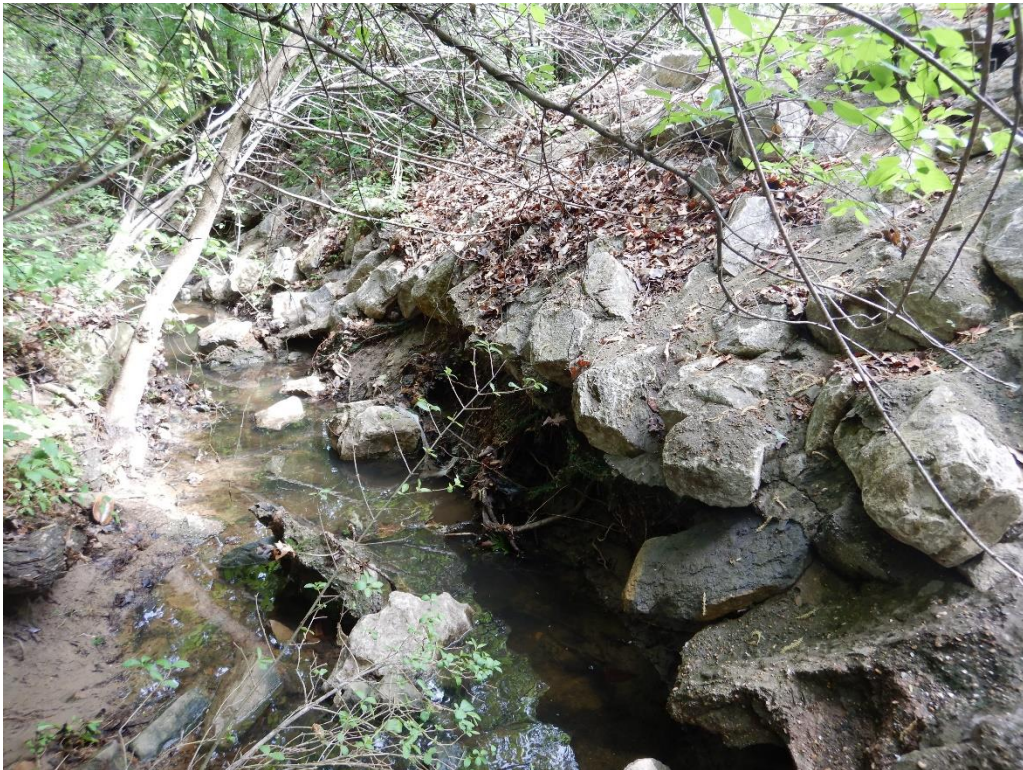
Station 15+15 - Looking downstream, this photo shows the undercutting below bank protection measures at this location (**Area of Concern #10**).

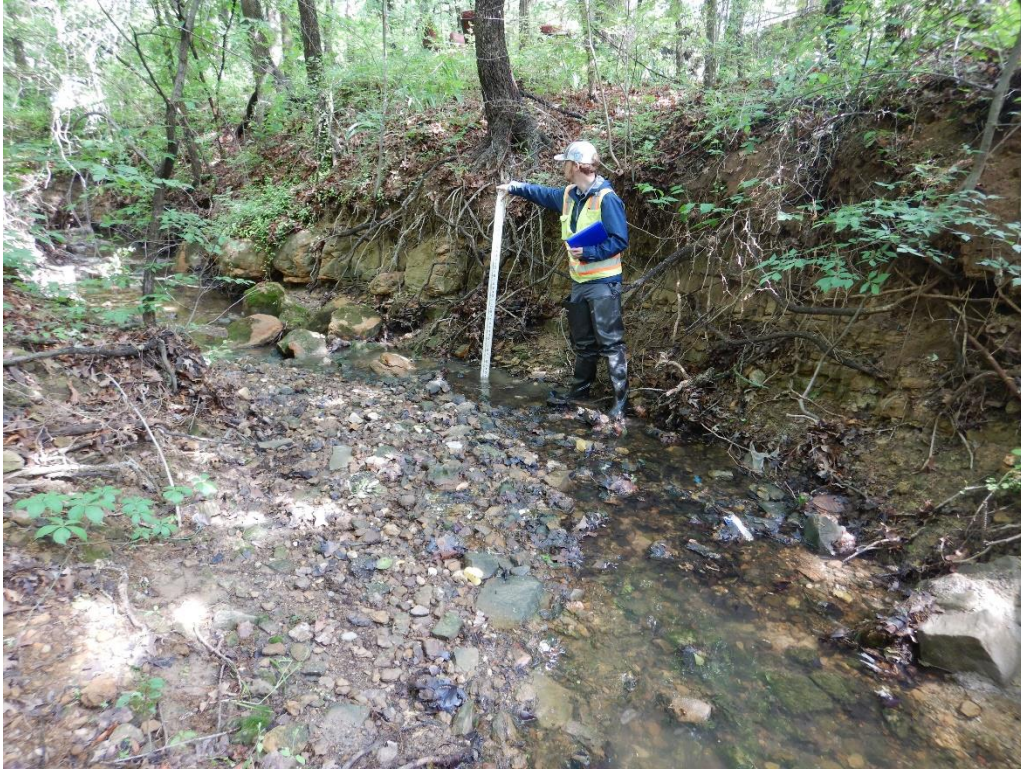
| Location | Impacted Features | Description | Priority |
|---|---|---|---|
| #11<br>Station 15+50 – 17+50 | Home Backyards | Bank erosion was observed through this section and could impact home backyards. This includes a failing bag wall and railroad tie wall bank protection at Station 17+50. | Moderate |

Station 16+25 - Looking downstream, this photo shows representative conditions of the channel in this area. Bank erosion may impact the backyards of homes (**Area of Concern #11**).

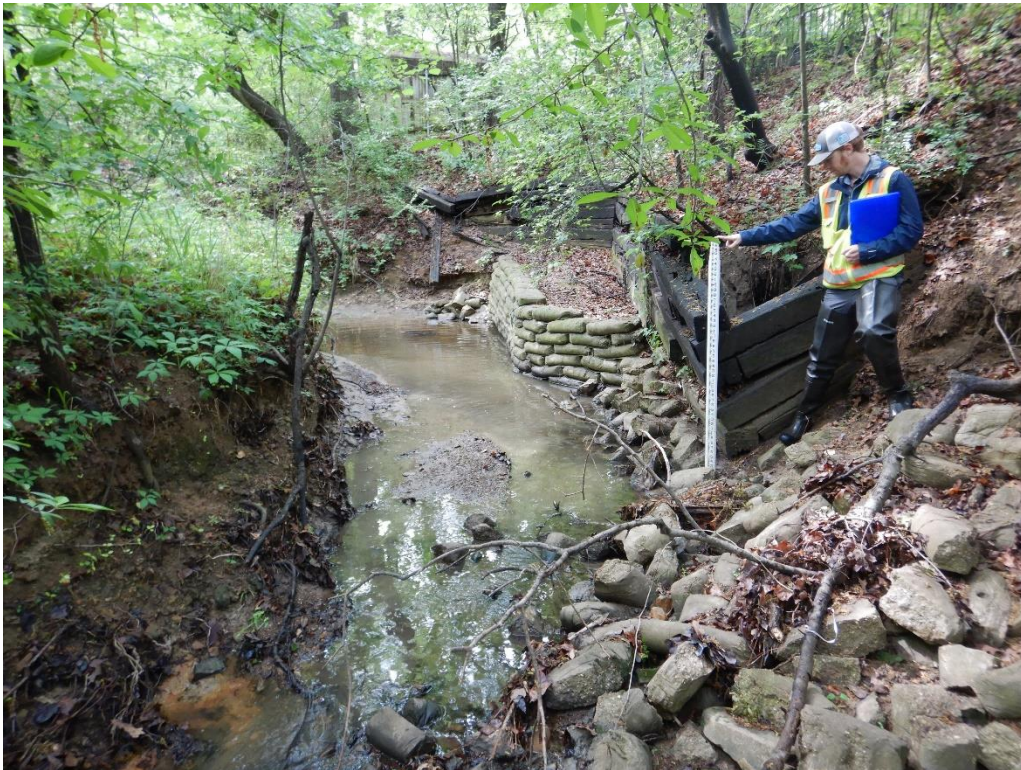
Station 17+50 - Looking upstream, this photo shows the failing bag wall and railroad tie wall behind a home (**Area of Concern #12**)

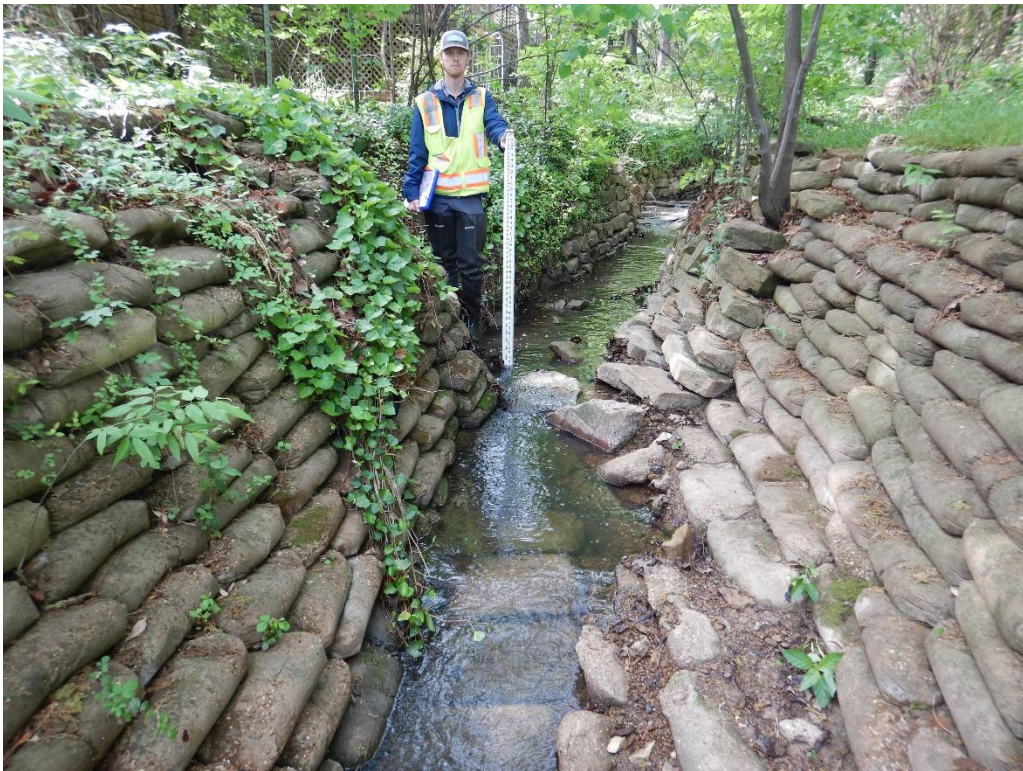
Station 24+00 - Looking upstream, this photo shows the homeowner constructed bank protection measures, at the end of the study area.
