# Forest Drive Stream Erosion Assessment and Conceptual Alternatives Development

September 2022

Prepared for:  
**City of Bedford, Texas**

**FREESE AND NICHOLS, INC.**

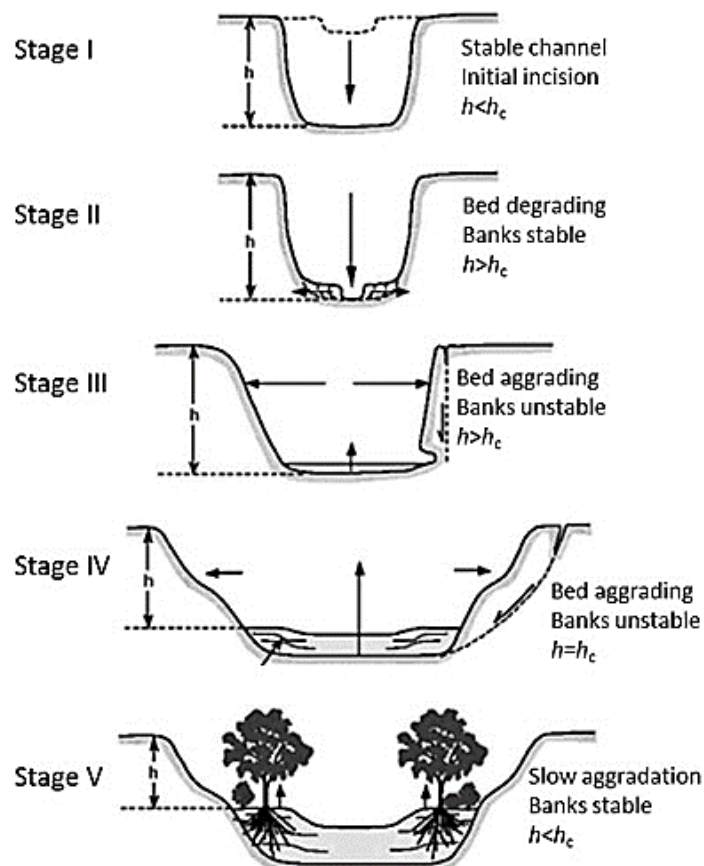
**Figure 1.** Diagram showing the stages of the Channel Evolution Model. Different segments of the Unnamed Tributary of Little Bear Creek are in various stages of this process.

Channel adjustment, and associated erosion, does not occur all at once, but progresses systematically in stages. This process is explained by the Channel Evolution Model (CEM). The CEM is a conceptual model that describes how streams change over time, following a disturbance within a watershed (**Figure 1**). In the first stage of this process a stream will begin to downcut (vertical erosion). After the stream banks become over steepened, stream bank erosion occurs (lateral erosion). Next aggradation by sediment sourced from the erosion and lateral adjustments continue until a new stable channel is formed. This process occurs from downstream to upstream, as instabilities known as headcuts migrate through the watershed. This process can take decades and explains that different segments along a stream can experience erosion at different periods in time.

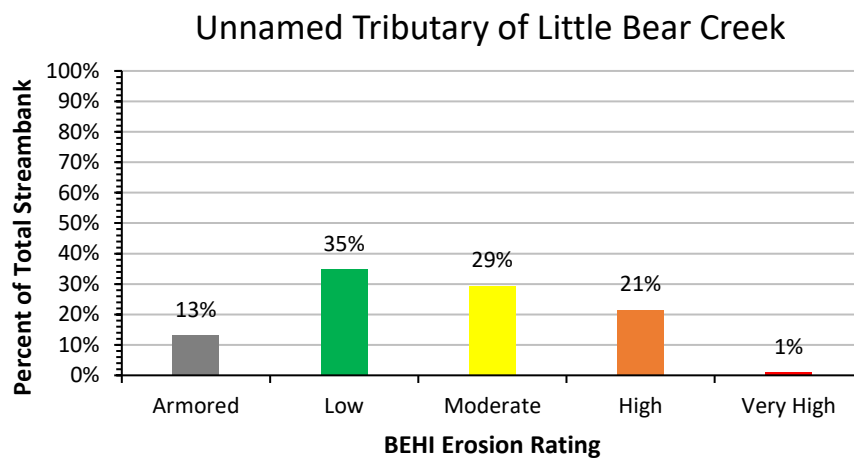
**Figure 2.** BEHI distribution within study area.

The distribution of BEHI ratings found on the stream banks of the unnamed tributary are presented in **Figure 2**. In general, BEHI scores were clustered within specific areas associated with the reaches described in the previous section.

**Station 0+00 - Station 5+00** - BEHI scores were generally low to moderate because vertical channel adjustments (downcutting/headcut migration) occur prior to significant channel widening. Lateral adjustments (bank erosion) will occur once the stream has downcut to a point where bank heights are too tall to support themselves.

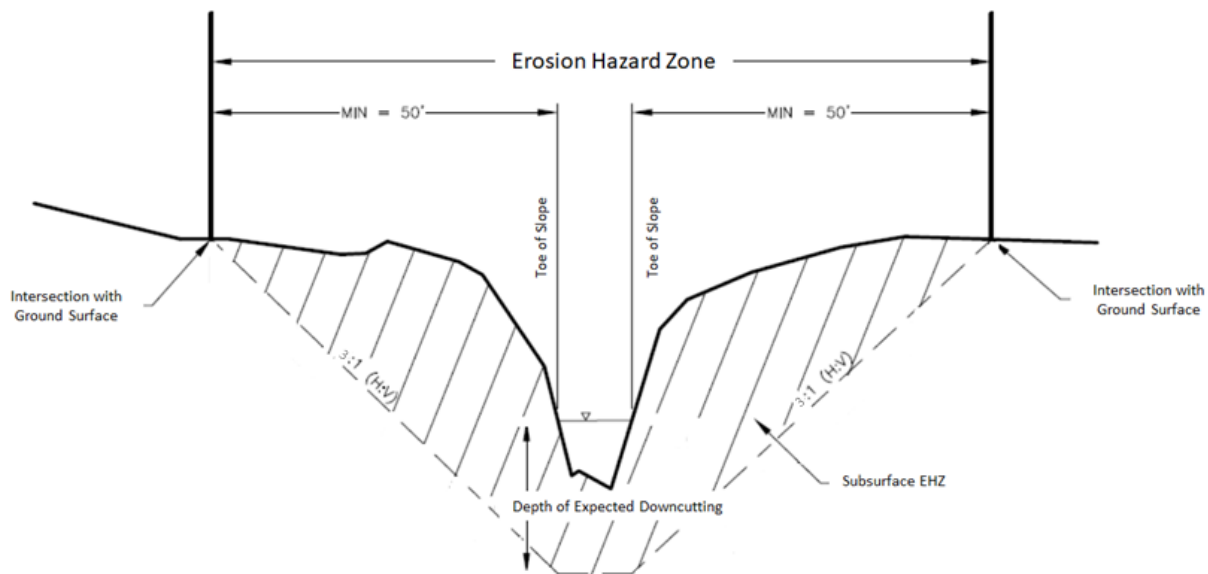
**Figure 3.** Diagram showing the delineation of a 3D erosion hazard zone at a stream cross-section.

For this analysis, cross-sections along the Unnamed Tributary of Little Bear Creek were cut from LiDAR data (supplemented with field observations and measurements) every 150- to 300-feet, ensuring that changes in channel geometry were captured. Next, a 3:1 slope from the toe of the stream bank beginning at the elevation of expected downcutting was projected outward to the ground surface. A 3:1 side slope was assumed to be the stable angle of repose for stream banks given their material composition. A minimum buffer of 50-feet from the toe of slope is also indicated by many methodologies, **Figure 3** diagrams how the EHZ is delineated.

The 3:1 bank projection was within the 50-foot minimum in many locations. Almost all homes adjacent to the stream were within the EHZ. As such, the EHZ was also calculated without a 50-foot minimum. However, this may underestimate the potential extent of erosion. Maps showing the erosion hazard are provided in **Exhibit C**.

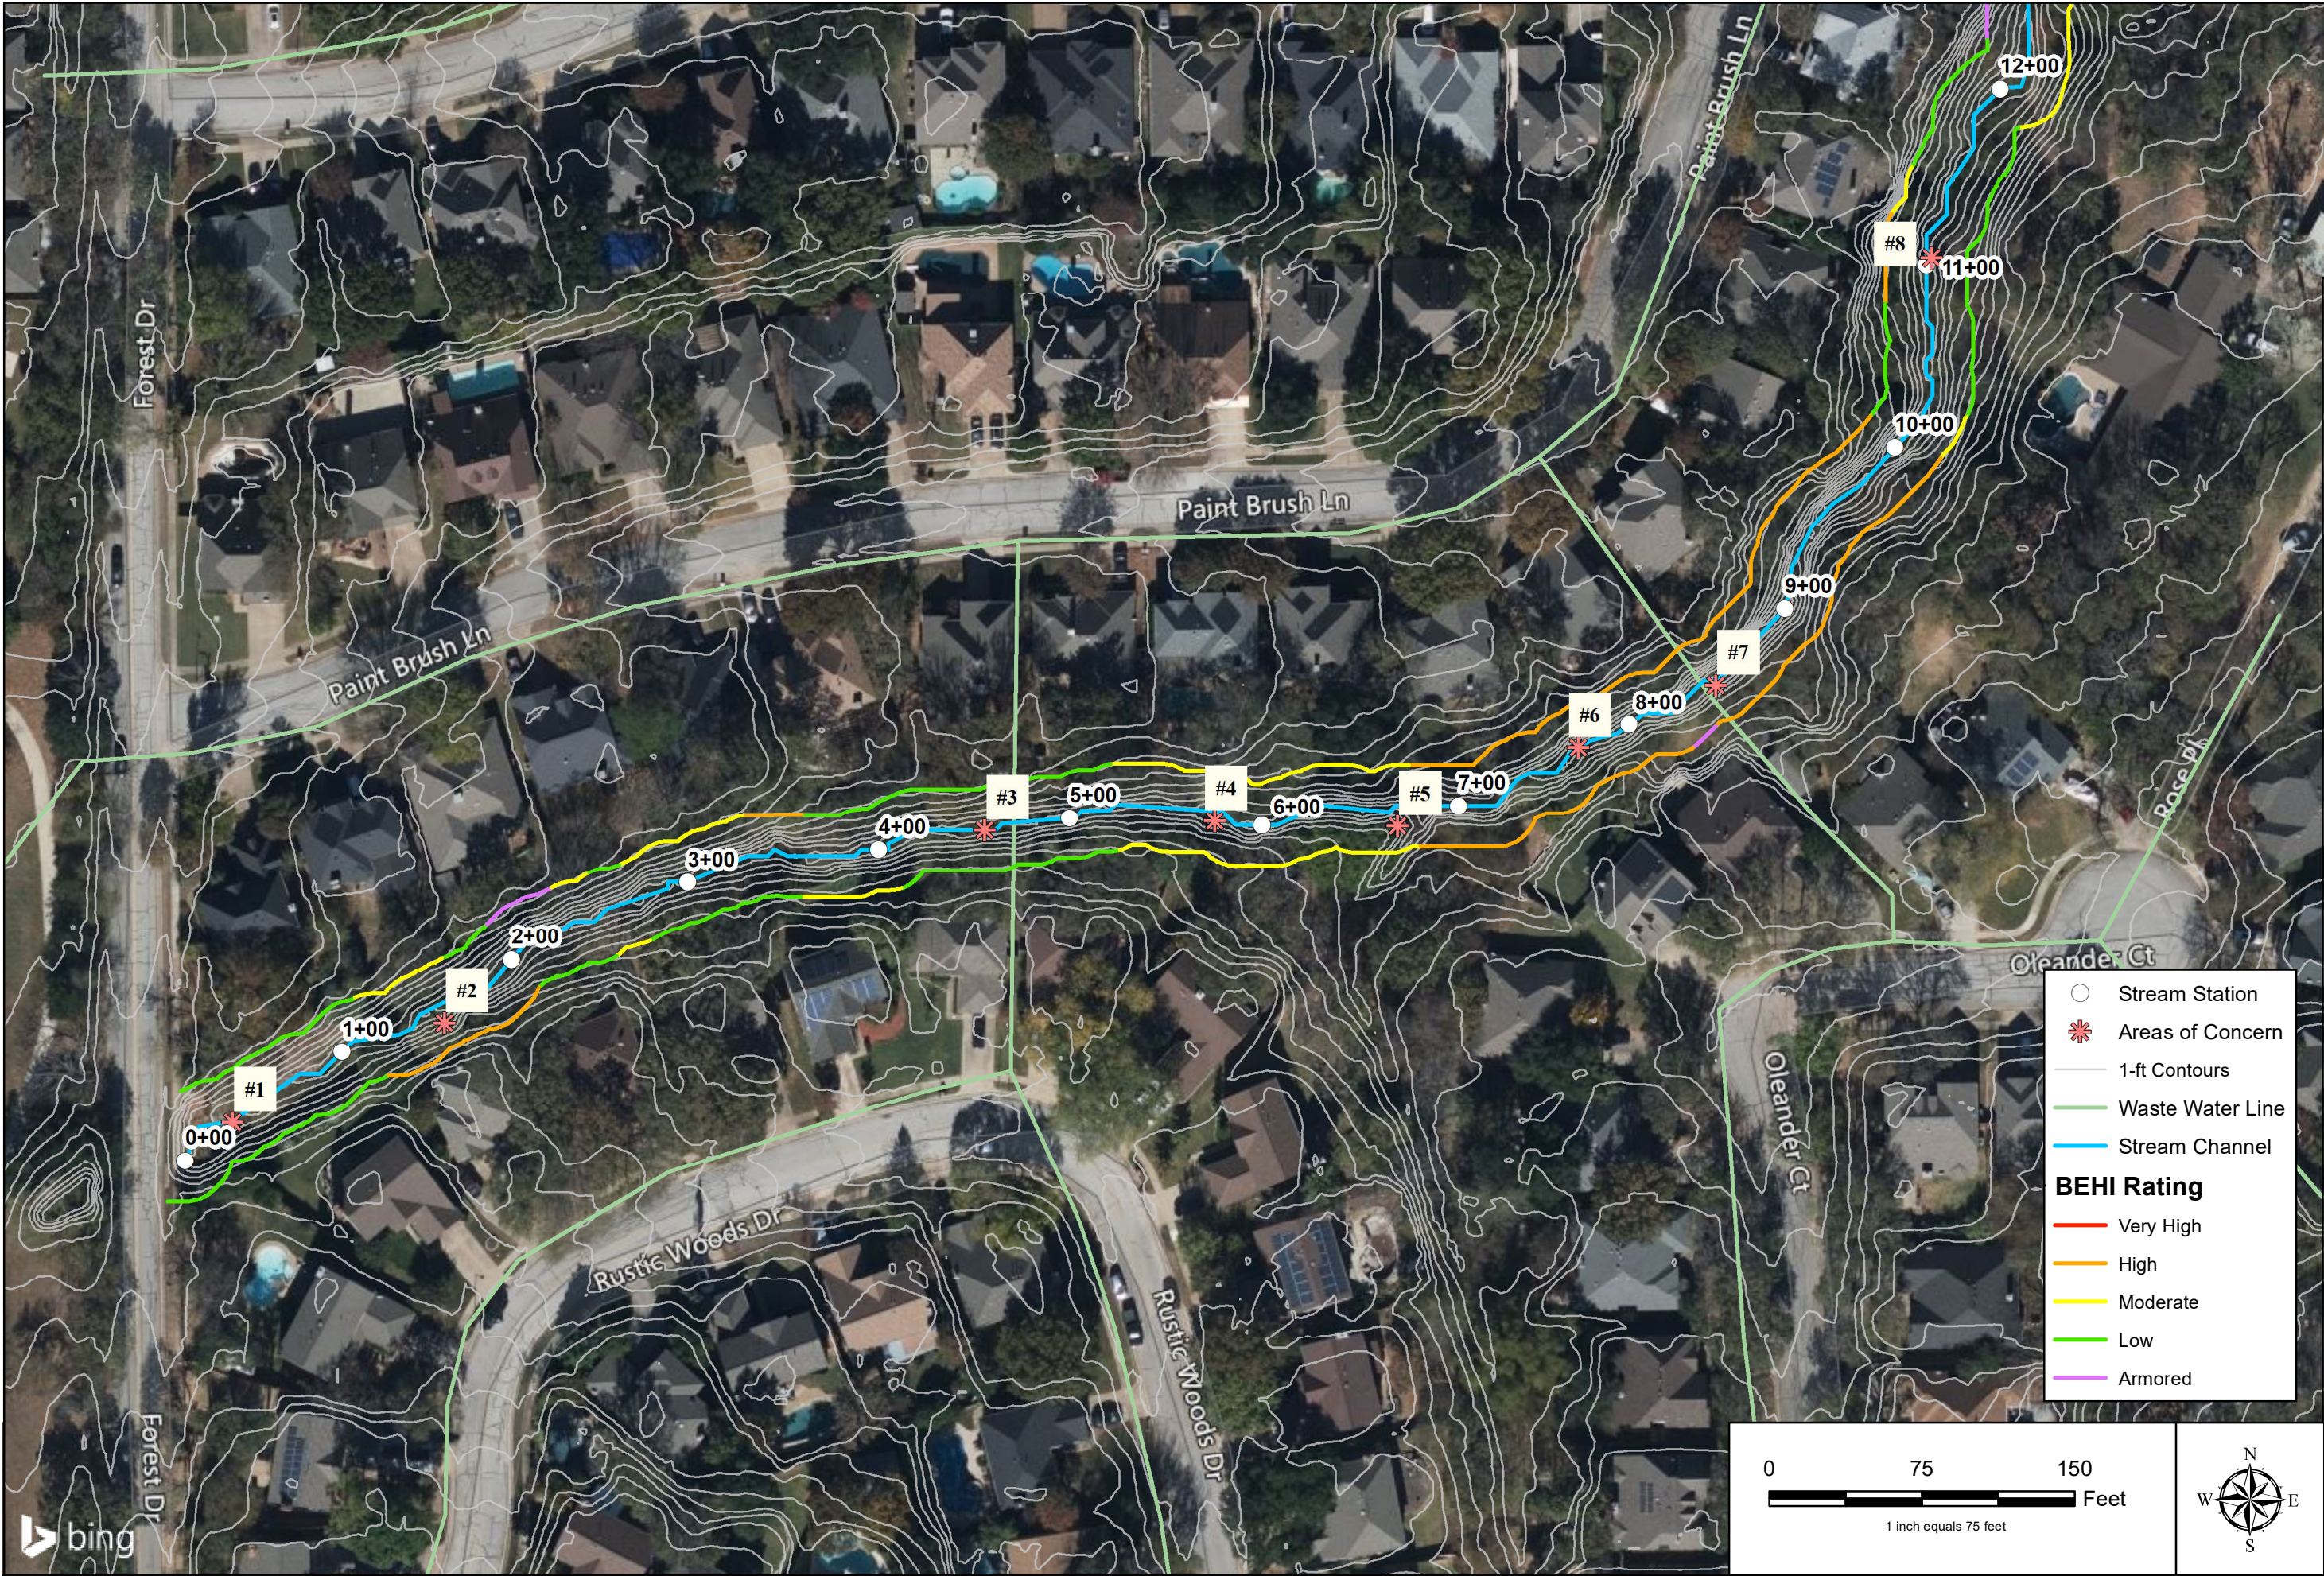
| <b>Bank Erosion Hazard Index (BEHI) Map</b> | | Station 0 - 1200 | | BOE14.195 | |

The Bank Erosion Hazard Index (BEHI) is a rapid technique to used evaluate a stream banks potential to erode laterally based on its characteristics. These characteristics include bank height, bankfull height, vegetation root depth, vegetation root density, bank slope steepness, and surface protection. Each of these characteristics were evaluated and then used to calculate a BEHI rating: Extreme, Very High, High, Moderate, Low, or Very Low potential to erode. Streambanks were mapped and rated using this system to indicate where erosion potential was the highest (**Exhibit B**).

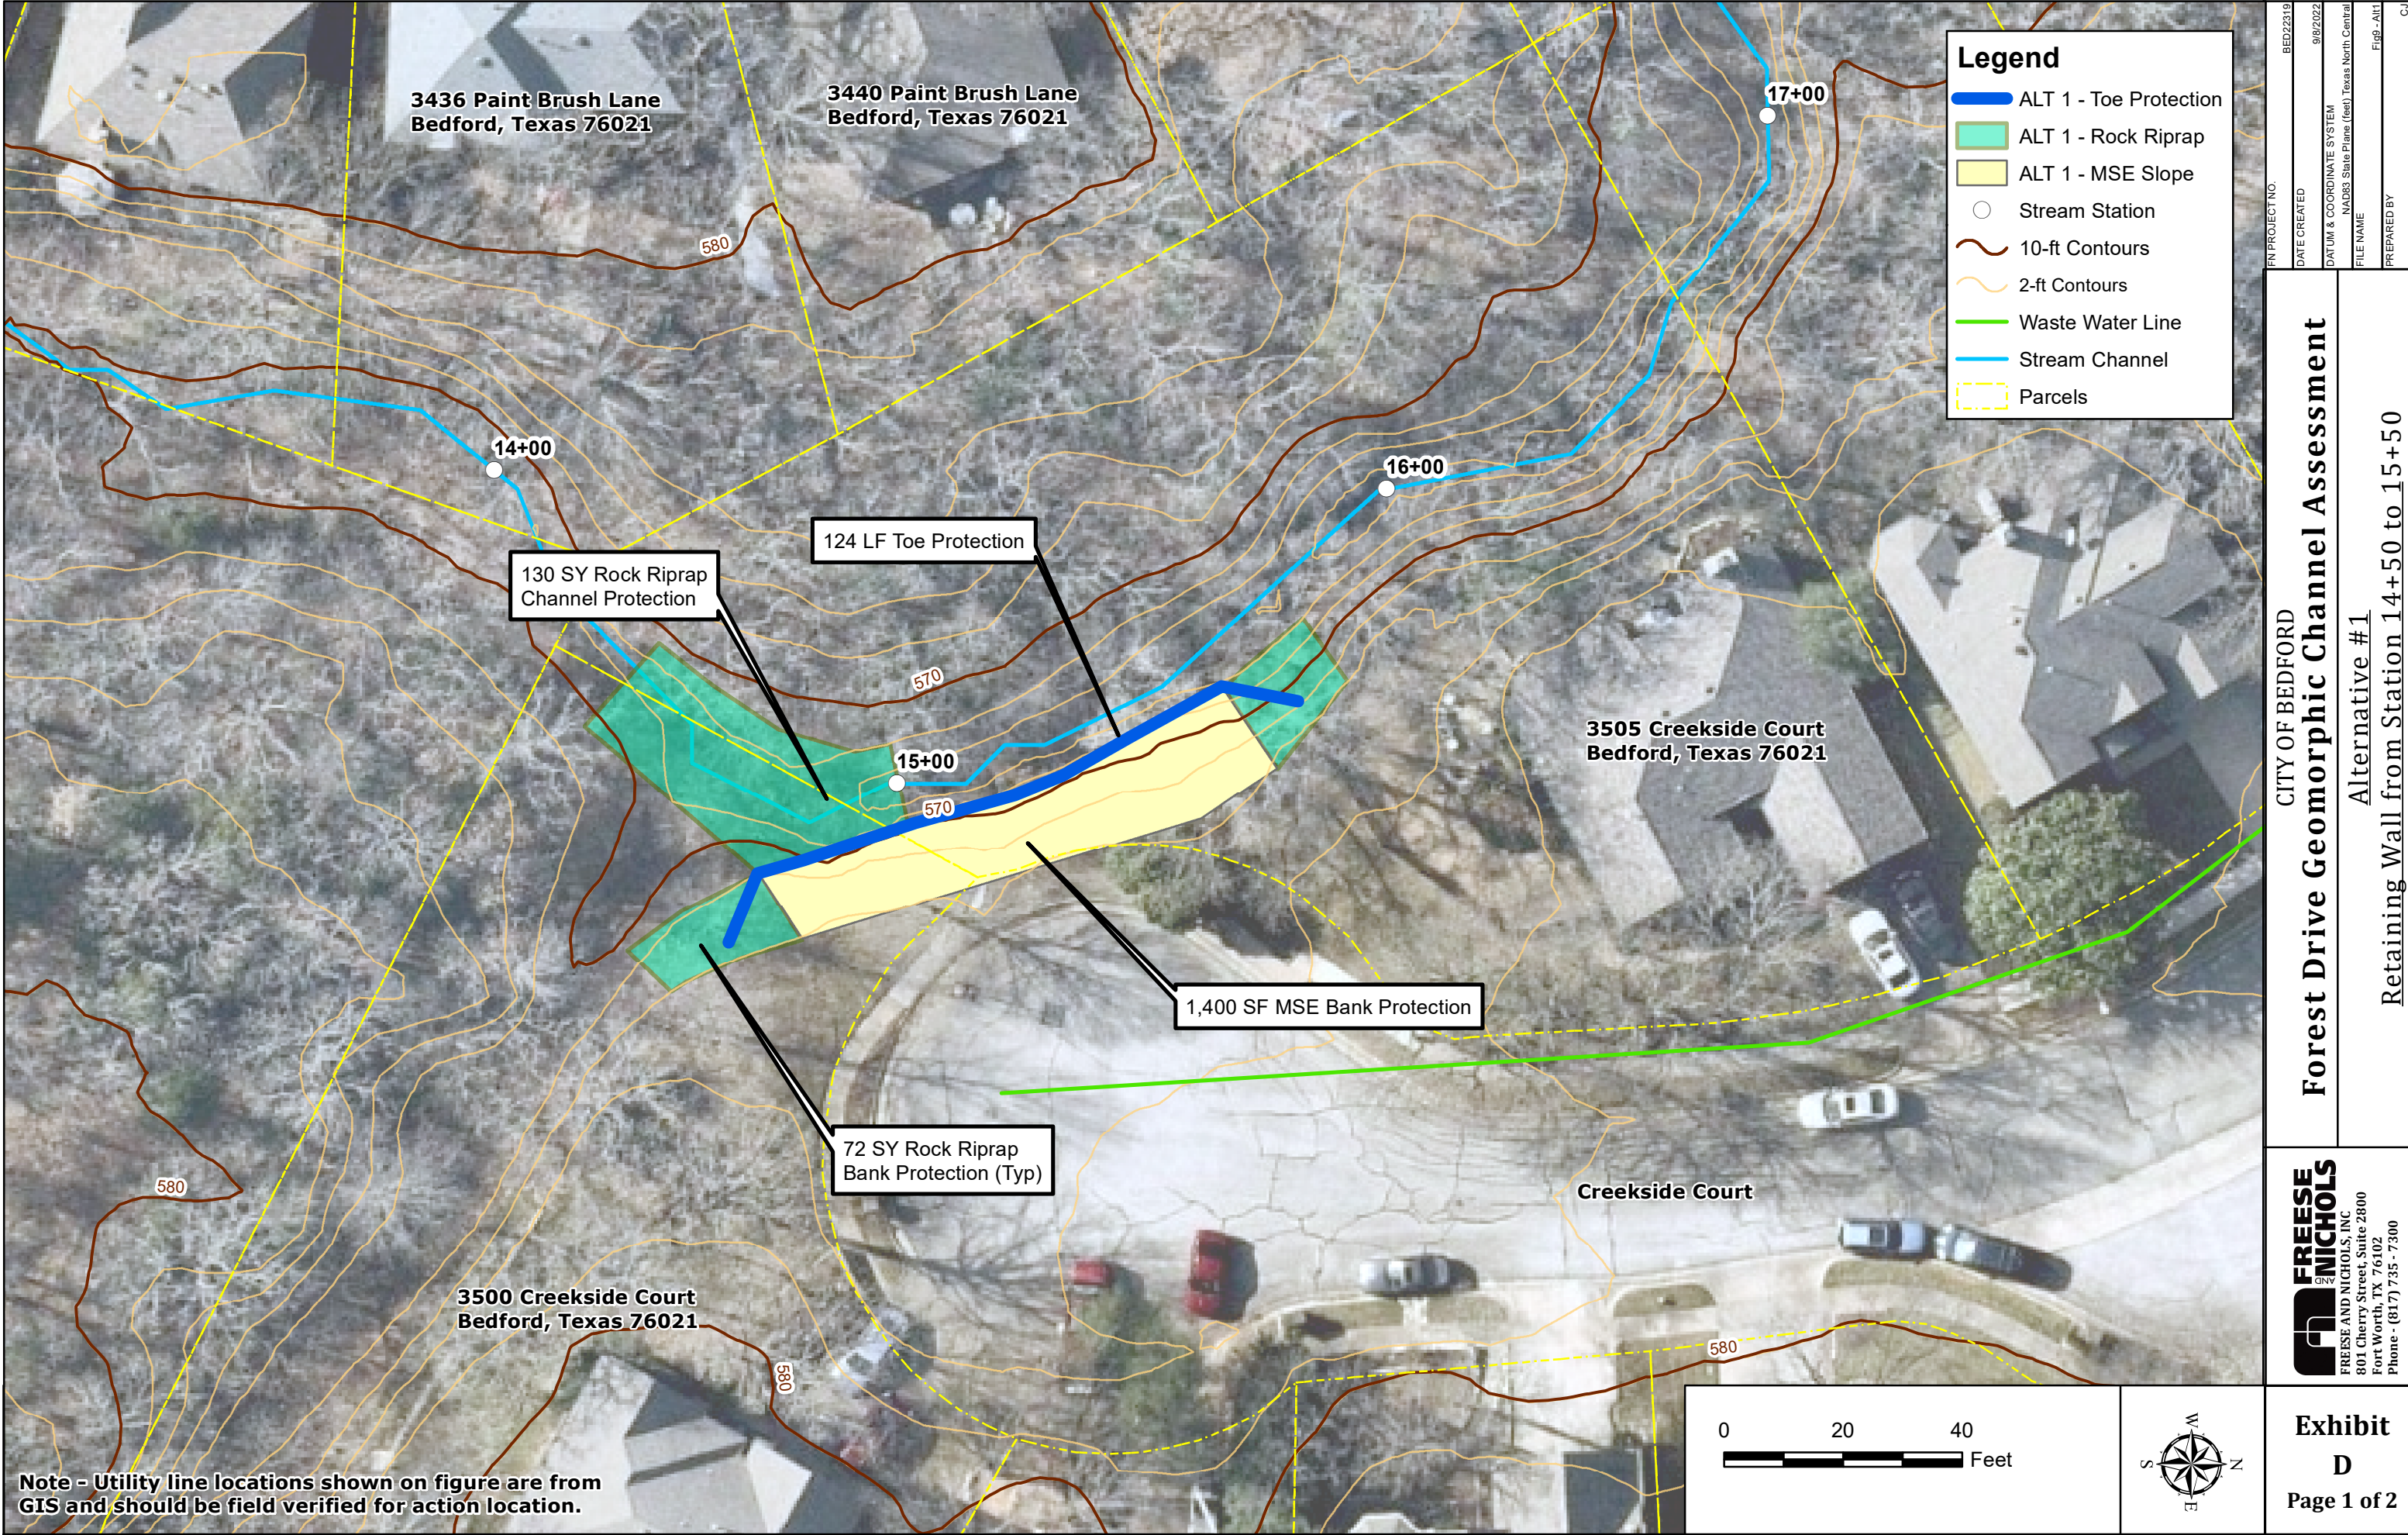
ALT 1 - Toe Protection

- At Station 14+50 to 15+50, grouted rip rap bank protection is present at the terminus of Creekside Ct. This bank stabilization measure is in poor condition due to scour undercutting the toe. Continued erosion may impact Creekside Ct.

| Location | Impacted Features | Description | Priority |
|---|---|---|---|
| #10<br>Station 14+50 – 15+00 | Creekside Ct, Upstream Impacts | Bank stabilization measures, in the form of grouted rock rip rap, to protect Creekside Court has been undercut by toe scour and is failing. This is due to channel downcutting below the depth of the protection measures. The headcut that initiated this issue is still present and at the upstream extent of the bank protection. Any measures to address this issue should also incorporate grade control to protect upstream reaches from migrating instabilities. | High |

The purpose of Alternative #1 is to protect an existing eroded slope along the right bank between stations 14+50 and 15+50. The failing bank is within 15 feet from the existing sidewalk along the western edge of the cul-de-sac of Creekside Court. The design will consist of removing the existing rock riprap bank protection which is currently being undermined. The bank will be reconstructed with a hard armored toe protection and mechanically stabilized earth (MSE) on top. Soil anchors are assumed because of the likeliness of traffic loading at the top of the bank. The toe protection will be a minimum of 6 feet in height with the bottom fully buried. Proposed riprap to be placed along the toe of wall and along the channel bottom to mitigate against a knickpoint migrating upstream. An exhibit was created to visually display design elements for Alternative #1 and is attached to this report in **Exhibit D**.

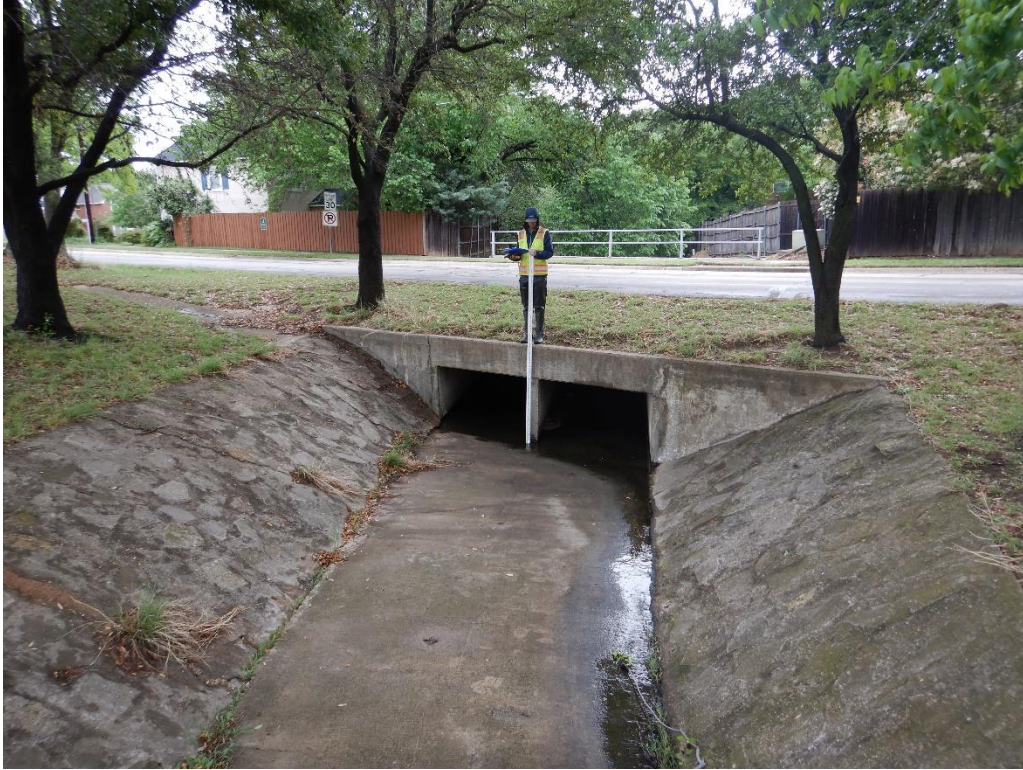
Upstream of Station 0+00 - Looking downstream at the Forest Drive culvert above the study area.

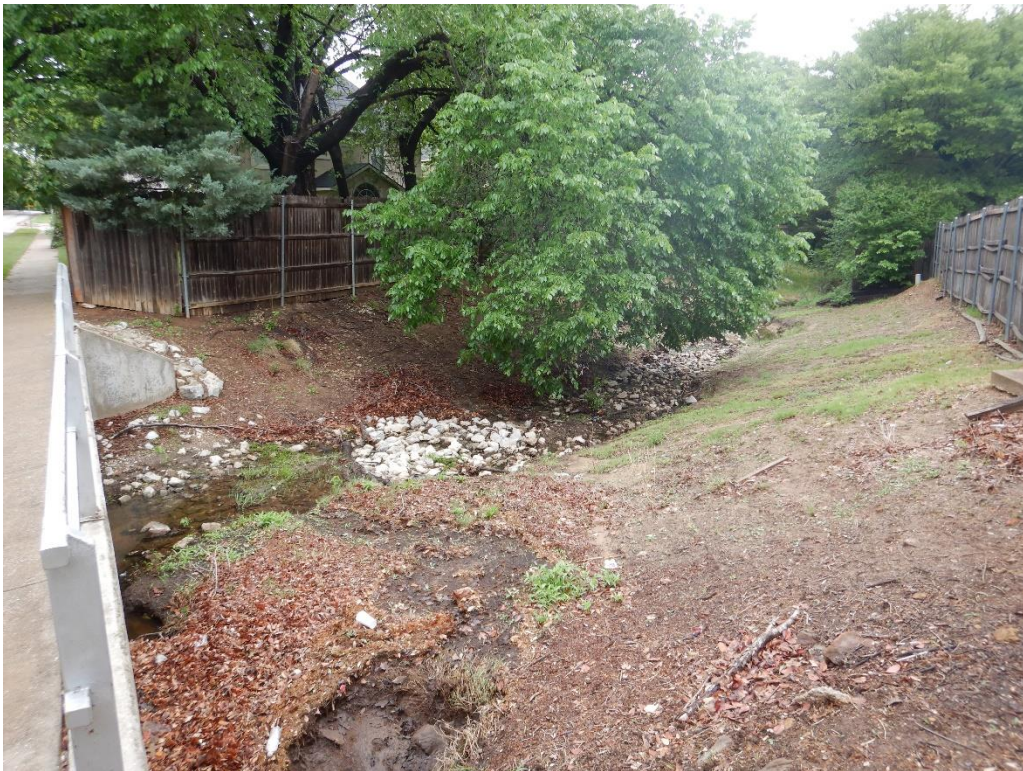
Station 0+00 -Looking downstream from Forest Drive.

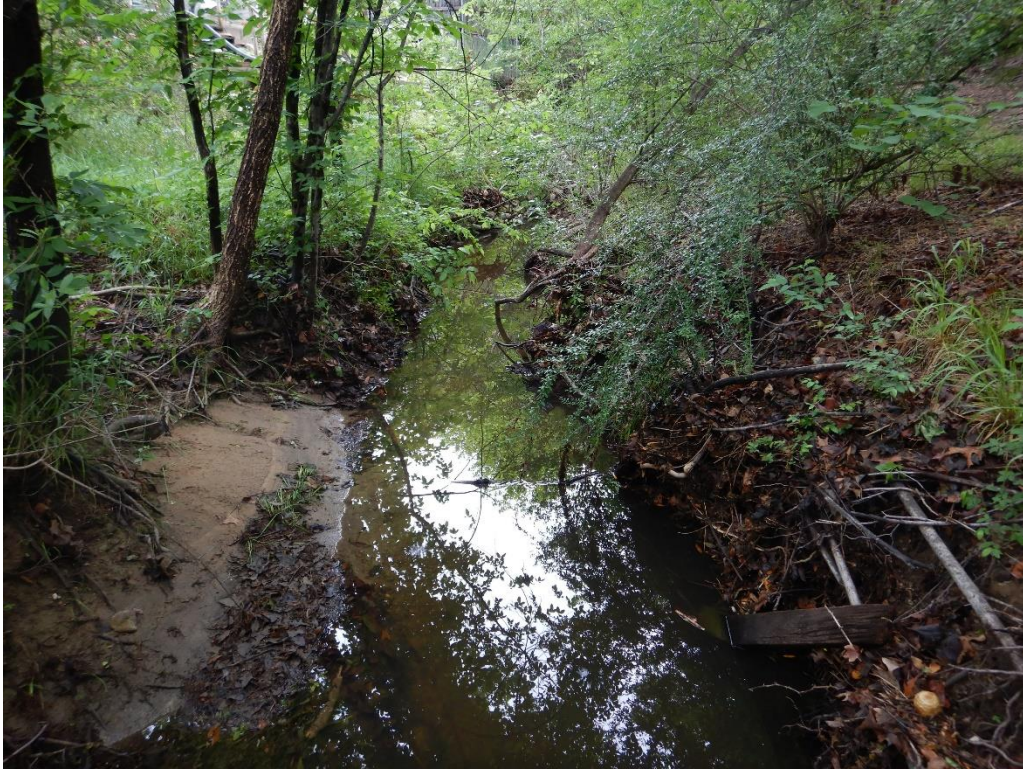
Station 11+75 - Looking downstream, this photo shows representative conditions of the stream channel in this area.

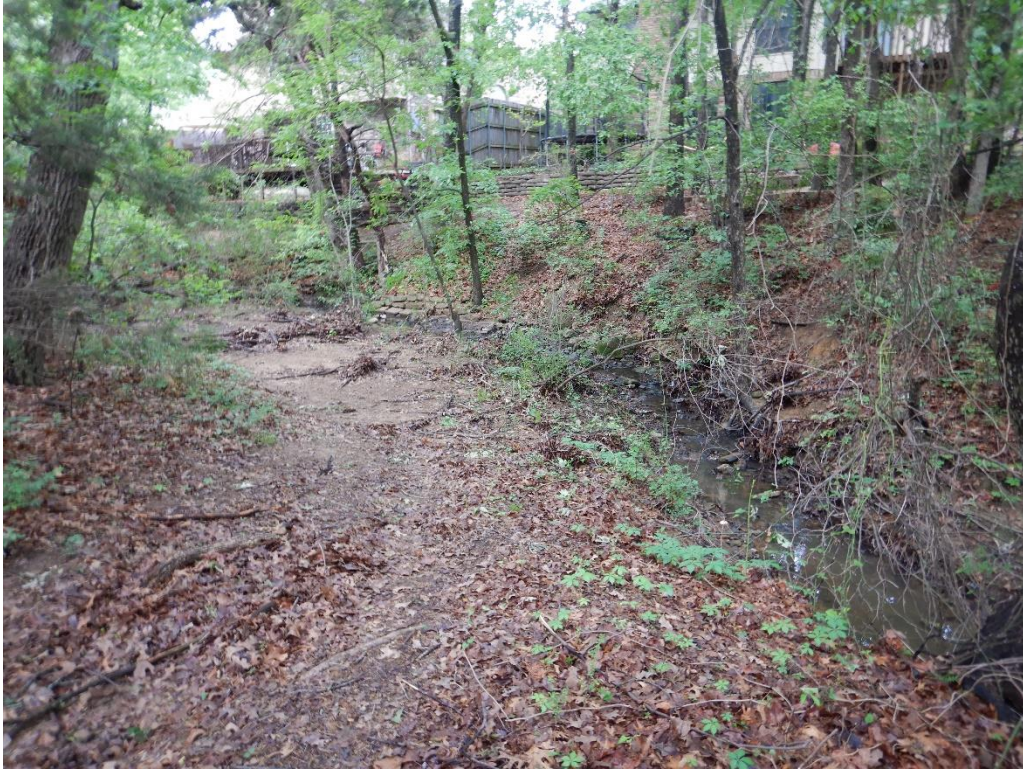
Station 13+75 - Looking upstream, this photo shows the representative conditions of the stream in this area.

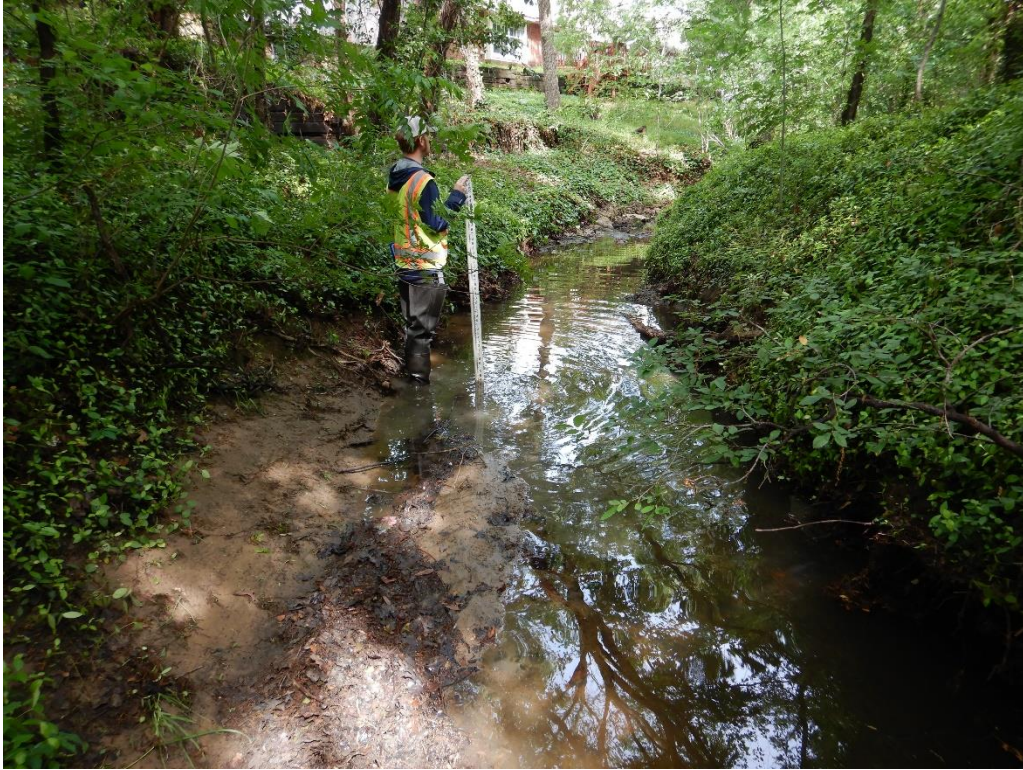
Station 18+75 - Looking downstream, this photo shows the representative stream conditions.

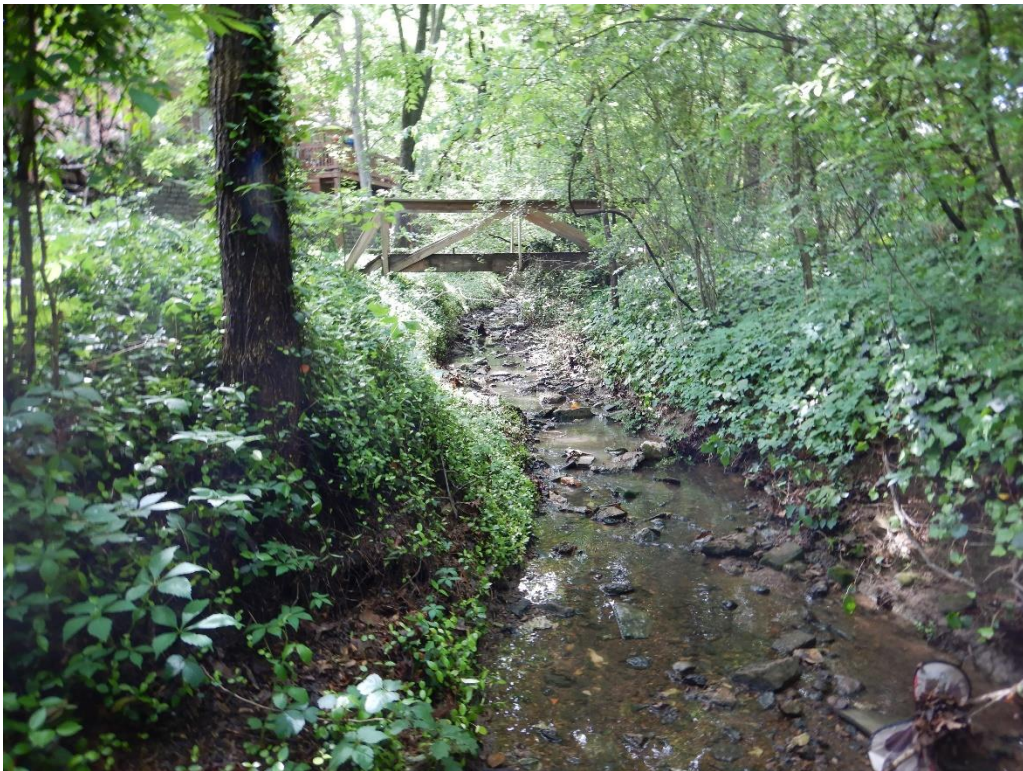
- Stormwater outfalls observed at Stations 19+00 and 22+00. Both outfalls were in good condition.
- A sewer line runs below the channel bottom between Station 20+25 and 22+25. This sewer line is not exposed and there is no evidence stream processes are currently affecting this structure.

Station 20+75 - Looking upstream, this photo shows the representative stream conditions.

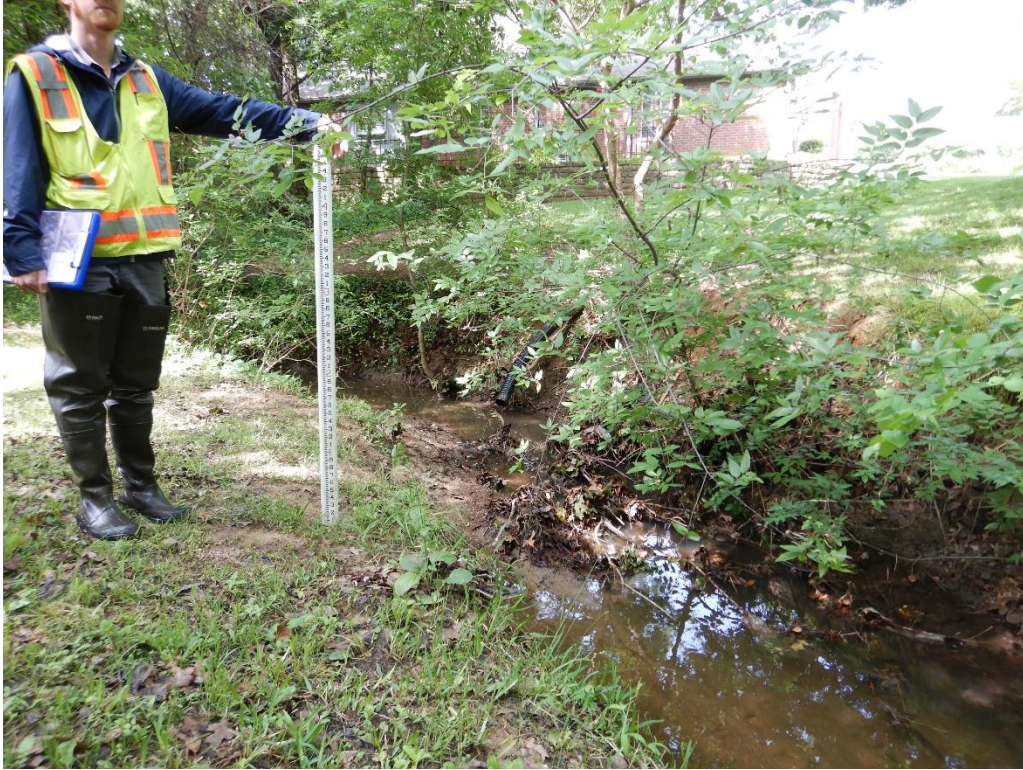
Station 22+00 - Looking upstream, this photo shows the representative stream conditions.

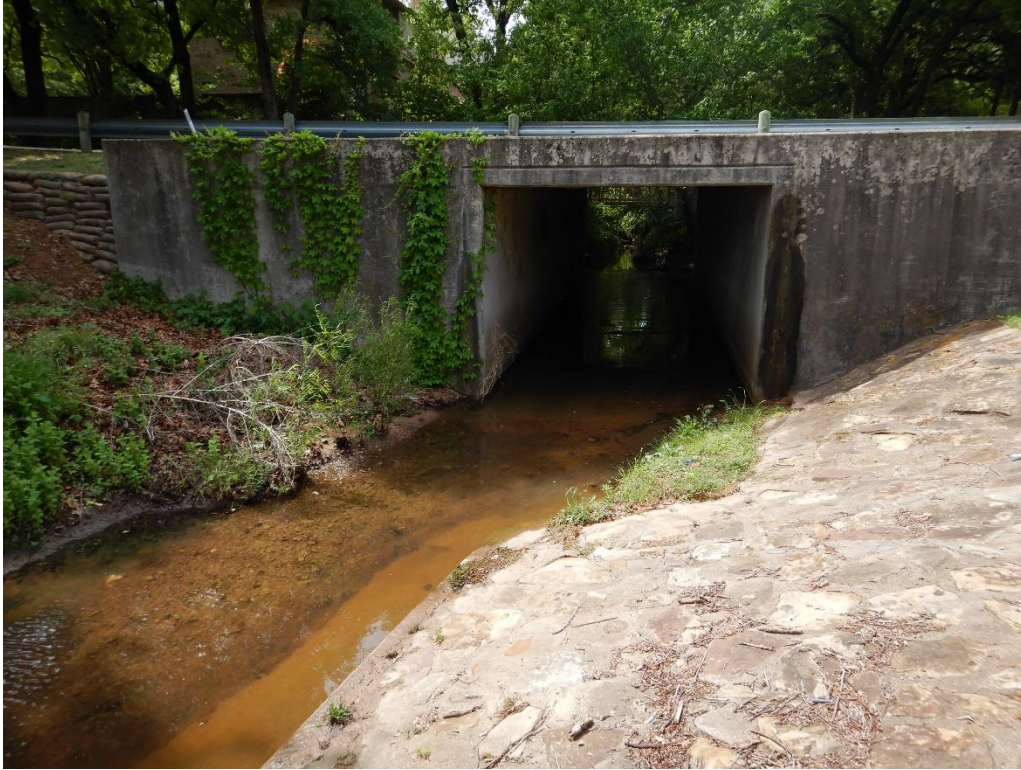
Downstream of Station 25+00 - Looking upstream at Cummings Drive from below the study area.

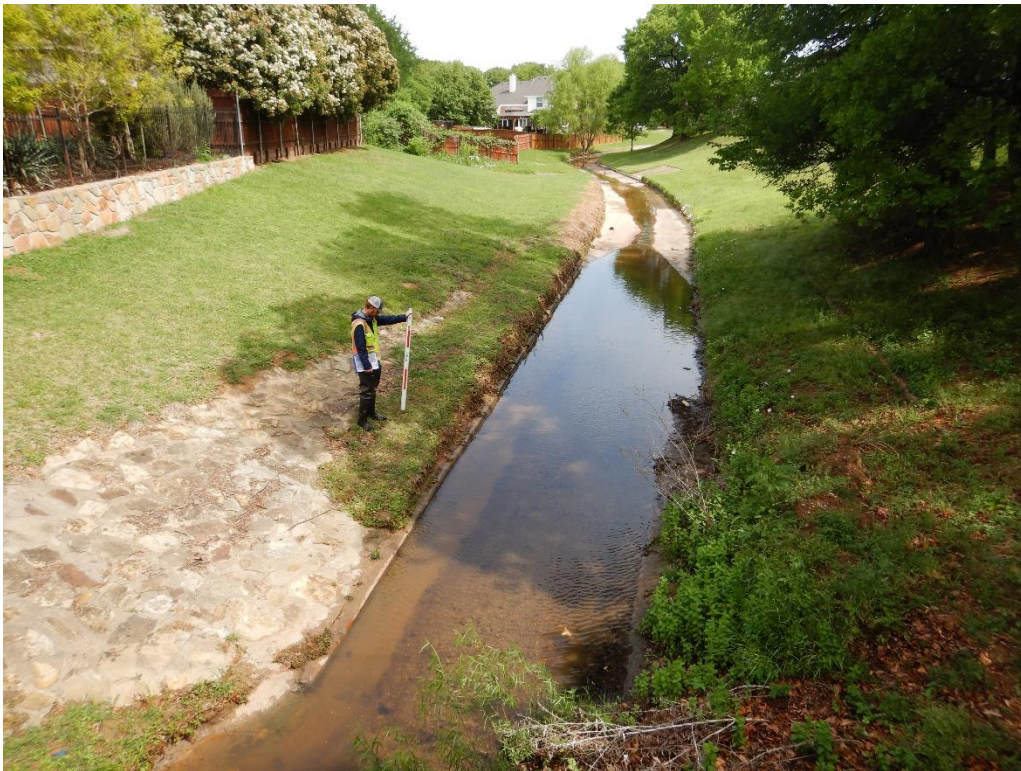
**Station 17+50 – 25+00** – The most downstream reach is in good condition. The concrete channel below Cummings drive acts as a hard point, preventing downcutting from progressing upstream. Minor vertical adjustments may still occur. Bank protection, likely installed by homeowners, also armors the banks in several locations. This area had minor evidence of erosion. Infrastructure through this reach includes:

Downstream of Station 25+00 - Looking downstream from Cummings Drive at the concrete lined channel below the study area.
